PHYTOTOXICOLOGY ASSESSMENT
SURVEY
IN THE VICINITY OF
LAMBTON COUNTY LANDFILL
SITE, SARNIA, 1991

PHYTOTOXICOLOGY ASSESSMENT SURVEY
IN THE VICINITY OF
LAMBTON COUNTY LANDFILL SITE, SARNIA - 1991

ARB No. 166-91-PHYTO

Phytotoxicology Section
Air Resources Branch

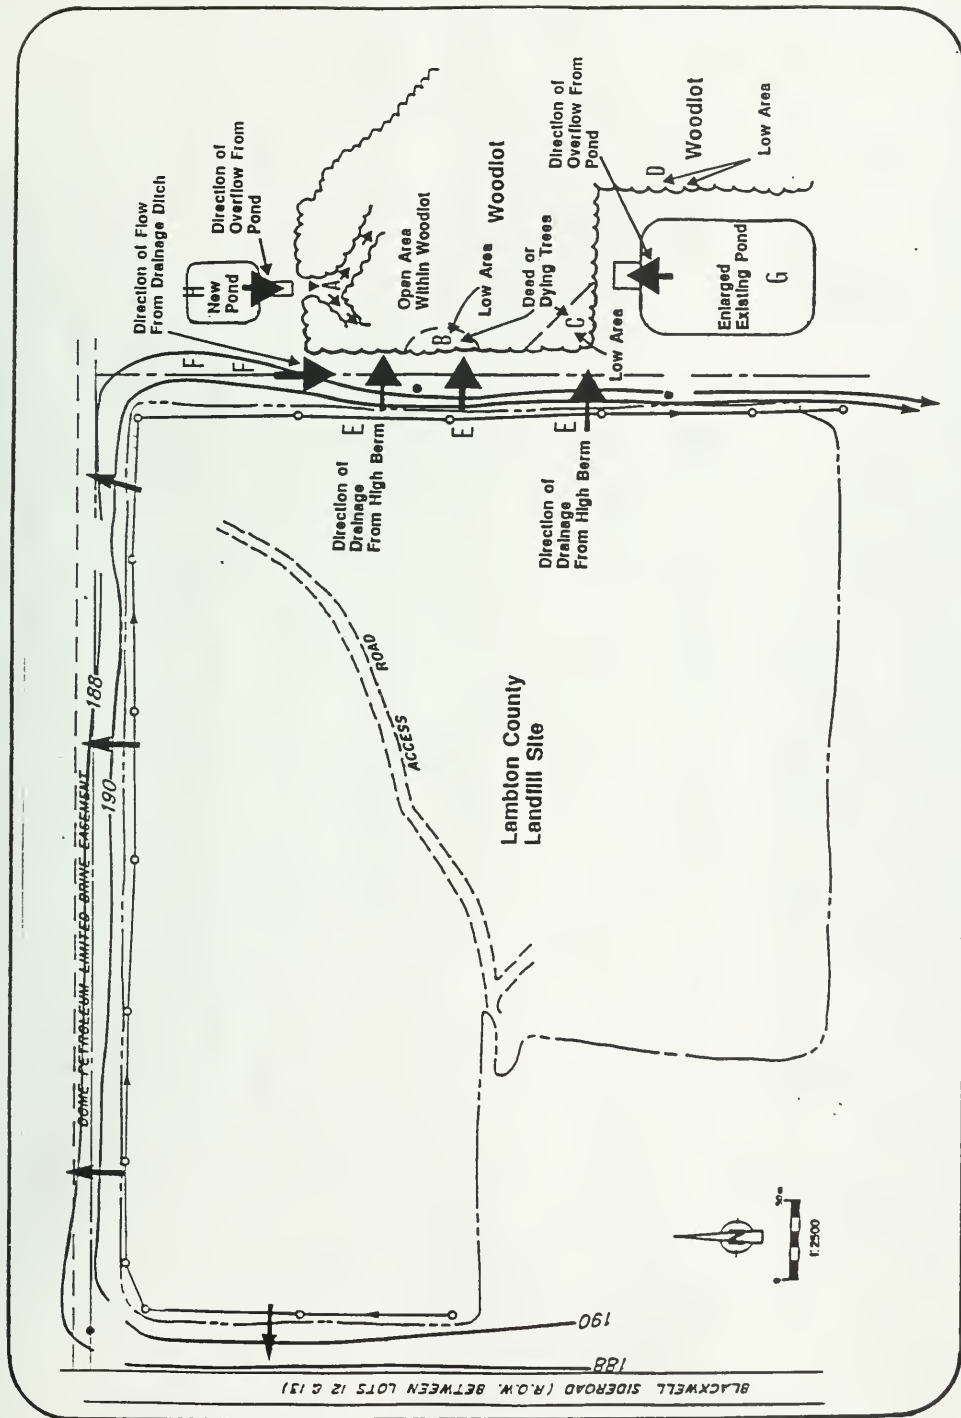
FIGURE: 1 Location of Woodlot in Relation to Lambton County Landfill Site

Phytotoxicology investigators A. Kuja and G. Vasiloff visited the Lambton County landfill site on September 10, 1991. Figure 1 shows the location of the small woodlot in relation to the landfill site and associated structures. A number of dead and dying silver maple trees were examined at three distinct locations (Sites A, B and C) within the woodlot located immediately east of the landfill site.

The greatest number of affected trees were situated at Sites B and C. At Site B, standing water covered the area surrounding the trees. At Site C, the soil was very muddy and water marks visible on tree trunks indicated that the flood waters had been at least 40 cm deep. At Site D, no dead or declining trees were observed. However, the soil was muddy and high water marks were visible on tree trunks.

The eastern perimeter of the landfill site consists of a massive berm that angles down severely to near the edge of the woodlot. Locations along the berm are identified as Site E in the figure 1. Several years ago, a keyed berm was installed along this stretch of this structure. This procedure involves the excavation of clay from a trench along the berm down to the compacted clay base. The excavated clay is compacted and placed back within the trench. A leachate collection pipe is installed in the middle of the compacted clay in the trench. From an engineering standpoint, a keyed berm constructed in this manner is considered impervious to the penetration of leachate from the landfill site. Sarnia Ministry staff have indicated that the keying was undertaken to prevent leachate from leaking from the landfill site. Although the decline of the trees is not a direct result of the construction, grade changes associated with the construction likely caused additional surface waters to collect within the low areas of the woodlot.

Farther north along the berm (Site F, Figure 1), the base of the berm was graded in such a way that surface water is channelled and flows in a southerly direction and ultimately drains into the western edge of the woodlot.

Phytotoxicology investigators examined dead and dying silver maple trees in a small woodlot adjacent to the Lambton County landfill site. Physical evidence indicated that grade changes of the berm along the eastern perimeter of the site and the discharge from two settling ponds had resulted in the flooding of low areas in the woodlot. Although silver maple are able to withstand intermittent flooding, it appears that the affected trees have been subjected to flooded soils over a protracted period of time. The wet conditions have already killed some of the trees. Other trees that are under considerable stress will eventually succumb if the flooding persists. No evidence of foliar injury related to toxic leachate was observed on vegetation located between the landfill site and the woodlot.

The construction of an adequate drainage to direct storm water around the woodlot and other appropriate locations should prevent further flooding and loss of trees.

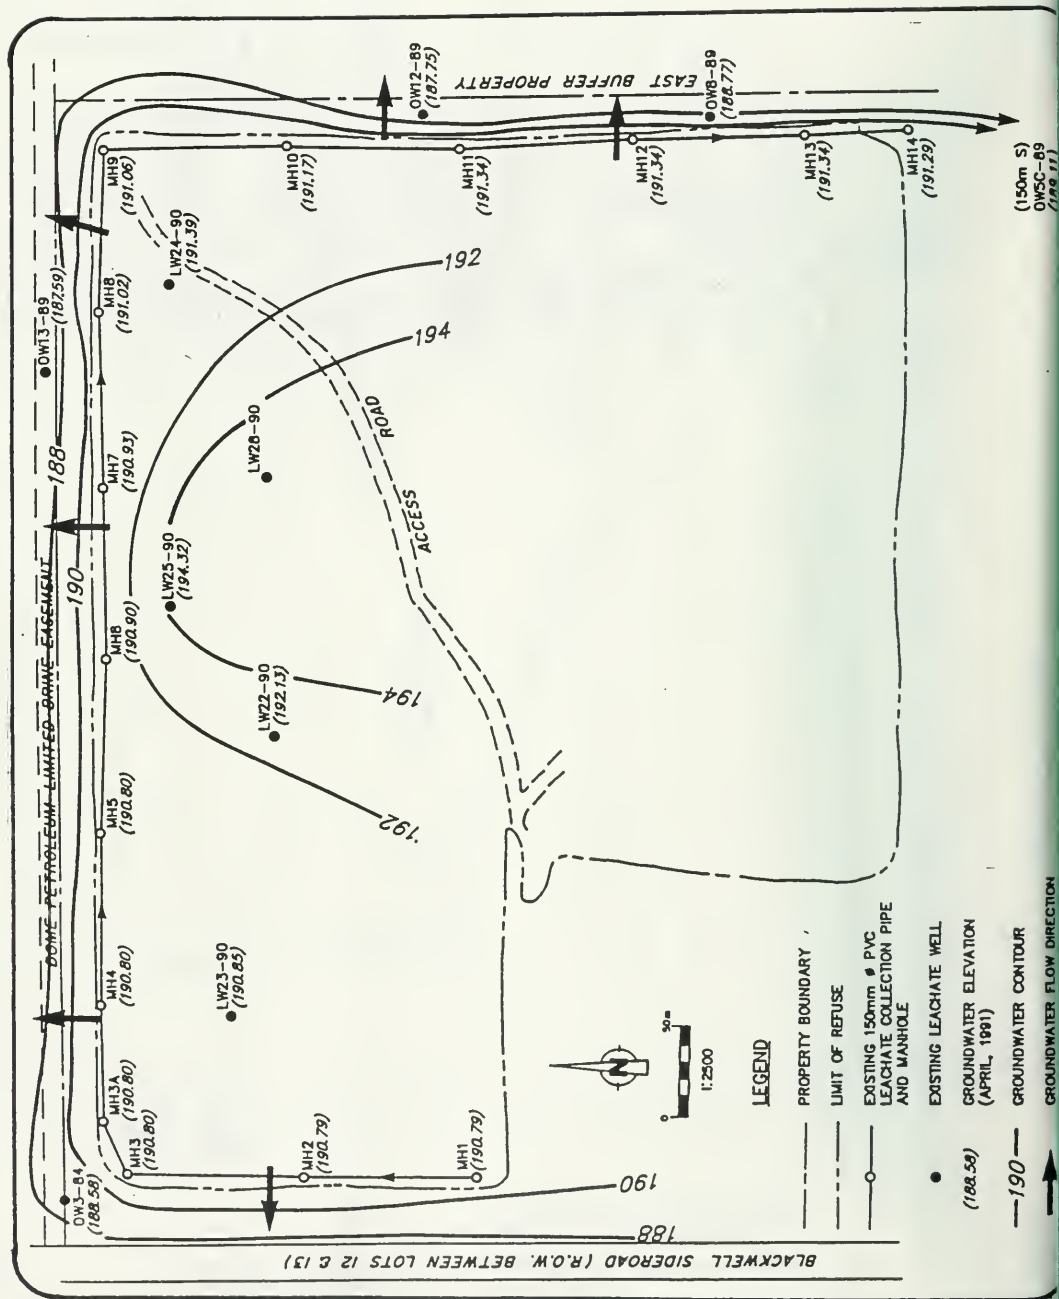
FIGURE: 2 Lambton County Landfill Site Showing Groundwater Potentiometric Surface

Examination of the berm and other landfill site-related structures adjacent to the woodlot indicated that grade changes had caused surface drainage waters from a number of locations to collect at the edge of the woodlot. Figure 2 is a view of the landfill site showing the groundwater potentiometric surface. This figure shows elevations of the perimeter areas of the landfill site and drainage flow directions.
